Volkswagen > New Beetle > 1998 - 2005

70 - Interior trim

Instrument panel, removing and installing

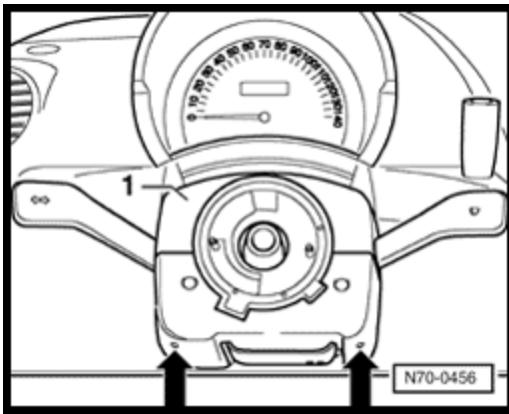
- Remove two screws -arrows-.
- Remove steering column switch upper trim -1-.

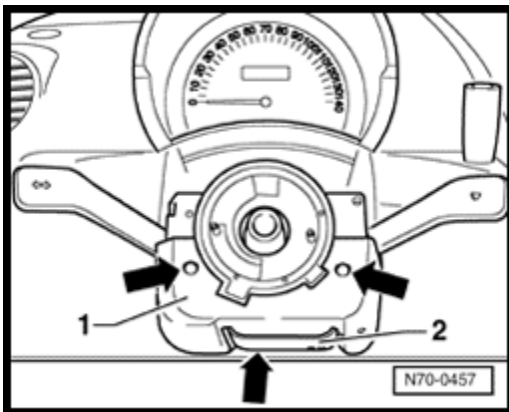
- Remove three screws -arrows-.
- Release steering wheel height adjustment -2-.
- Remove steering column switch lower trim-1-.

Handle for height adjustment can be removed (two screws) to ease removal of lower trim.

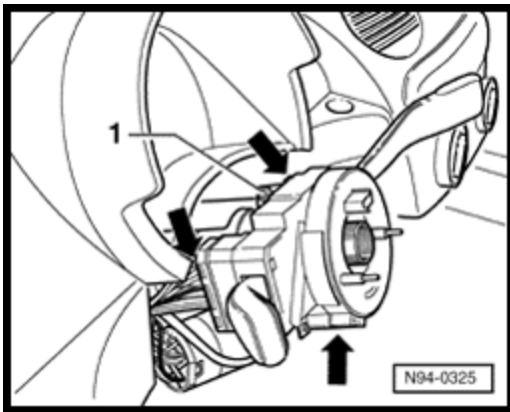
- Remove Hex socket (Allen key) head bolt -1-.
- Disconnect connectors -arrows- from steering column switches.
- Remove steering column switch.

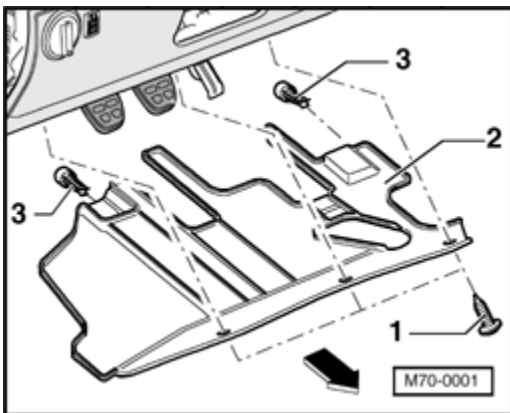
- Remove screws -1-.
- Remove driver's side footwell cover -2- from retainers -3-.

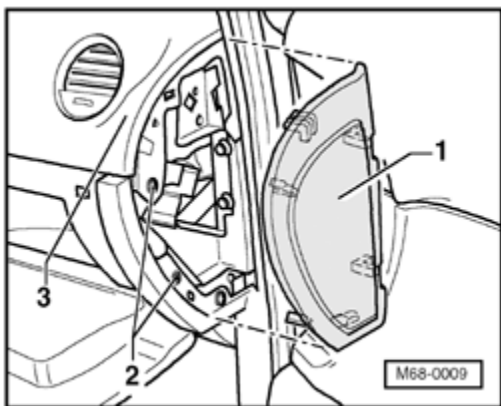
- Release rear of cover -1- from instrument panel -3- and remove instrument panel to rear.
- Remove bolts/screws -2-.

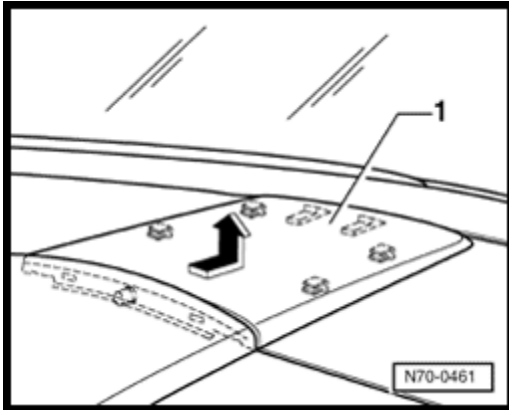
- Slide plenum chamber center cover -1- forward out of its locking device and Remove of instrument panel -arrow-.

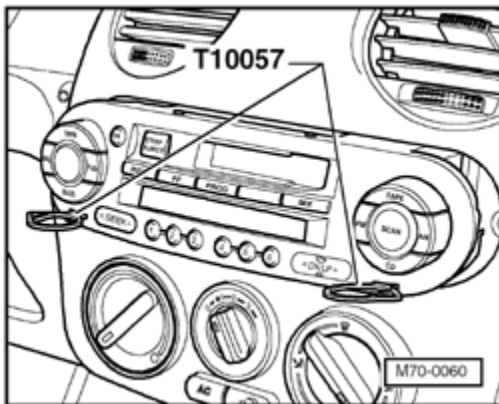
- Insert a release tool T10057 into all slots until they engage.
- Remove radio from instrument panel using grip rings of release tools and disconnect electrical connections.

- ◆ Radio release tool T10057 must not be pushed to side or canted when being used.
- ◆ Press locking lugs on sides of radio unit to remove release tools.

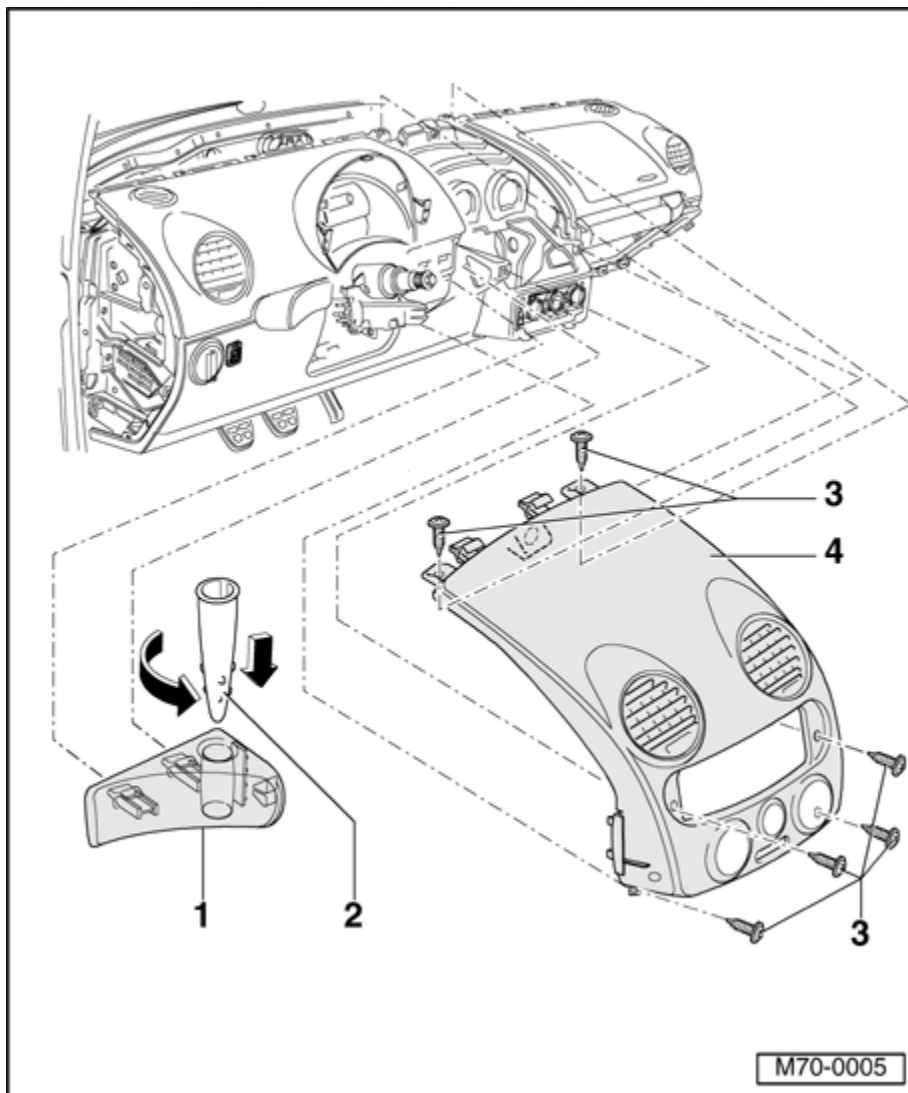
- Remove bracket -1- for flower vase -2- from instrument panel.
- Disconnect hazard warning light switch connection
- Disconnect airbag deactivation warning lamp -K145- connection 05.03 ►
- Remove screws -3- and remove center air outlet console -4- from instrument panel.

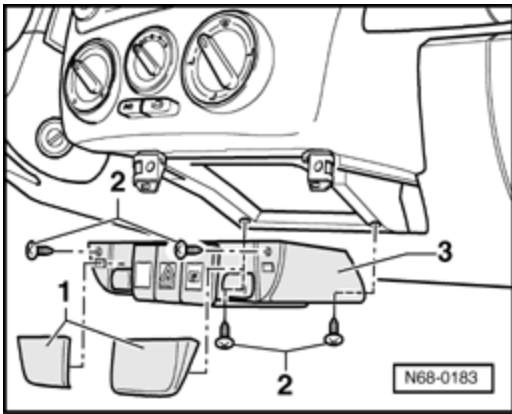
- Pry off cover caps -1- and remove screws -2-.
- Remove switch mounting -3- from retainer.
- Disconnect electrical connectors from switches.

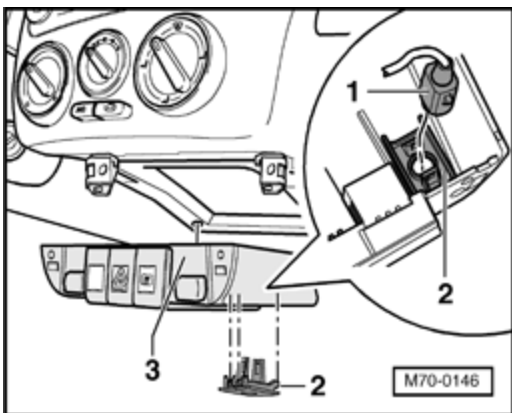
- Remove auxiliary input jack -1- from bracket -2-.
- If necessary, remove bracket -2- from switch mounting -3-.

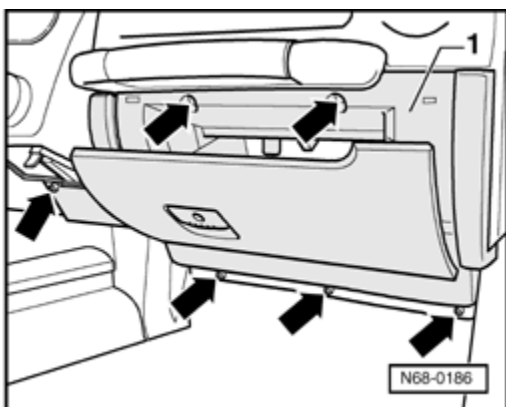
- Remove screws -arrows- (Qty. 6) (screws in center of vehicle are hidden under cover caps).
- Remove glove box -1-.
- Disconnect glove box lighting connections.

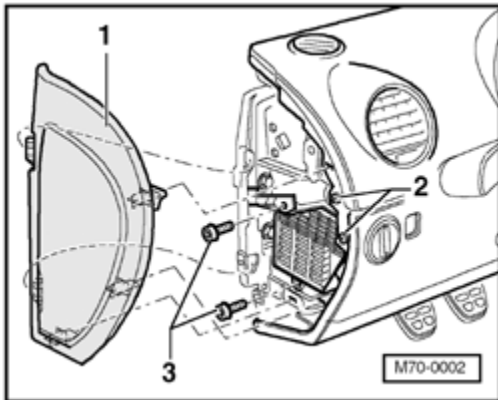
- Release rear of cover -1- from instrument panel and remove.
- Remove screws -2- and two screws -3- of fuse holder.

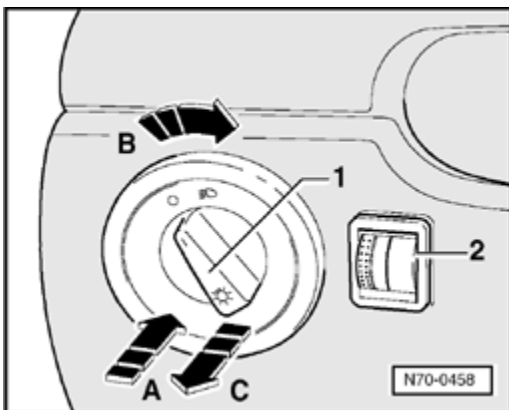
- Turn rotary part -1- of lighting switch to position 0.
- Press rotary part inward -arrow A- and then to right -arrow B-.
- Remove switch out of instrument panel -arrow C- and disconnect electrical connections.
- Unclip head light range control switch -2- and disconnect connector.

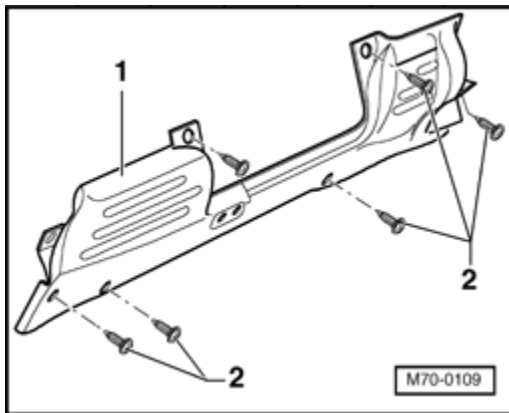
- Remove screws -2-.
- Remove impact plate -1- (Convertible).

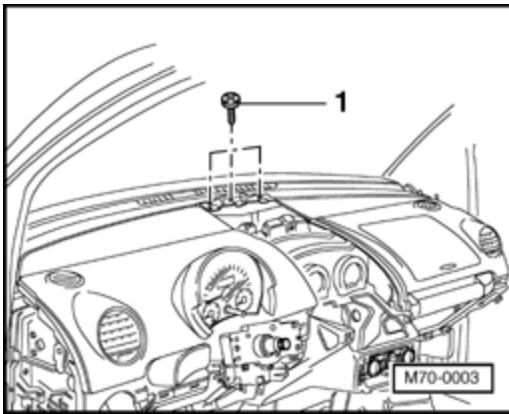
- Remove Qty. 3 screws -1-.

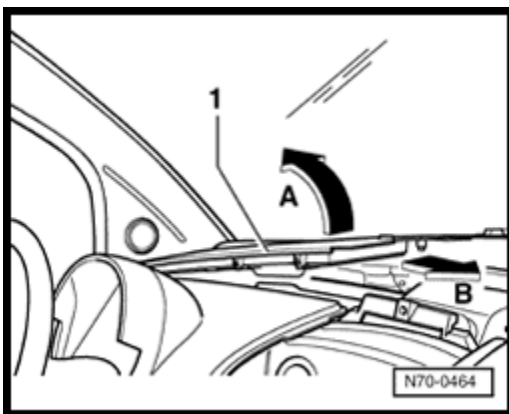
- Lift left-hand plenum chamber cover -1- in center of instrument panel -arrow A-, this action unclips panel (front and rear edges are clipped).
- Remove cover -1- toward center of instrument panel and out of retainers in A-pillar - arrow B-.

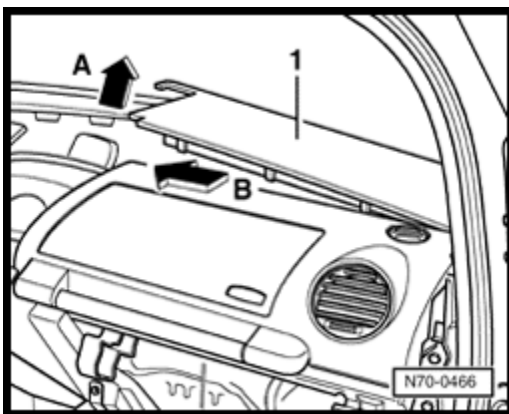
- Lift right-hand plenum chamber cover -1- in center of instrument panel -arrow A-, this action unclips panel (front and rear edges are clipped).

- Remove cover -1- toward center of instrument panel and out of retainers in A-pillar - arrow B-.

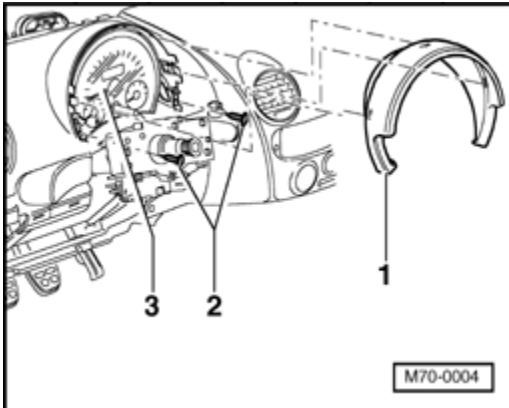
- Unclip trim -1-.
- Remove bolts/screws -2-.
- Remove instrument panel insert -3-.
- Disconnect multi-pin connections on back of instrument panel insert.

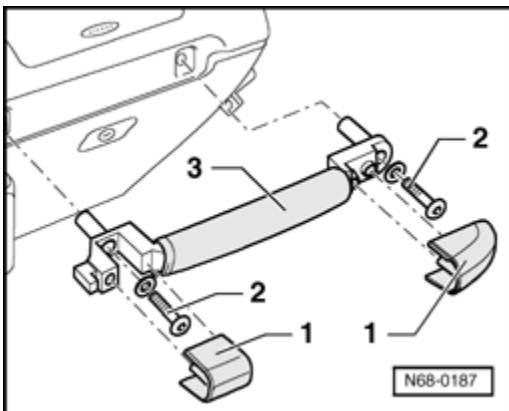
Models without a mobile telephone/cell phone retainer installed

- Remove covers-1-.
- Remove screws -2- (Tightening torque 8 Nm) and remove handle -3- from instrument panel.

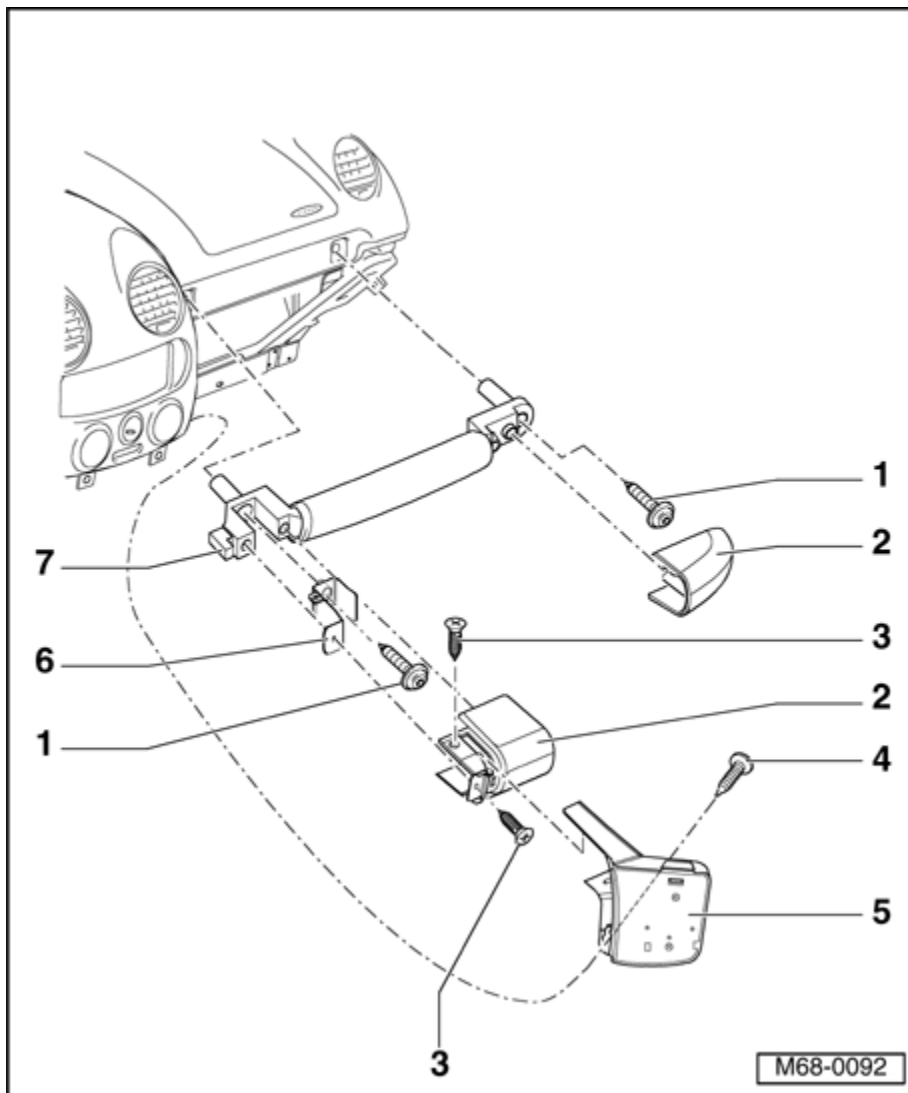
Models with mobile telephone/cell phone retainer

- Remove screws -3- and -4- from mobile telephone/cell phone retainer
- Remove mobile telephone/cell phone retainer -5-.
- Remove cover -2-.
- Remove screws -1- and remove left retaining plate -6-. Take hand hold -7- off instrument panel.

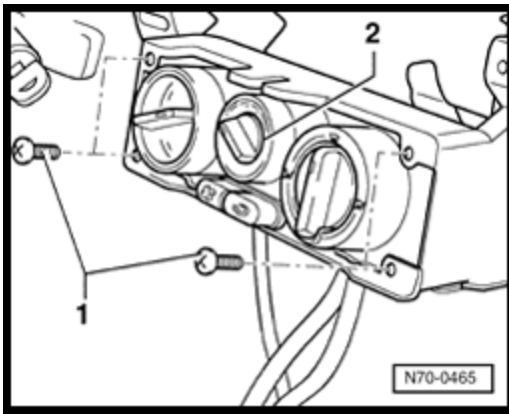
- Remove 4 screws -1-.

- Press heating and ventilation control -2- with attached cables under instrument panel.

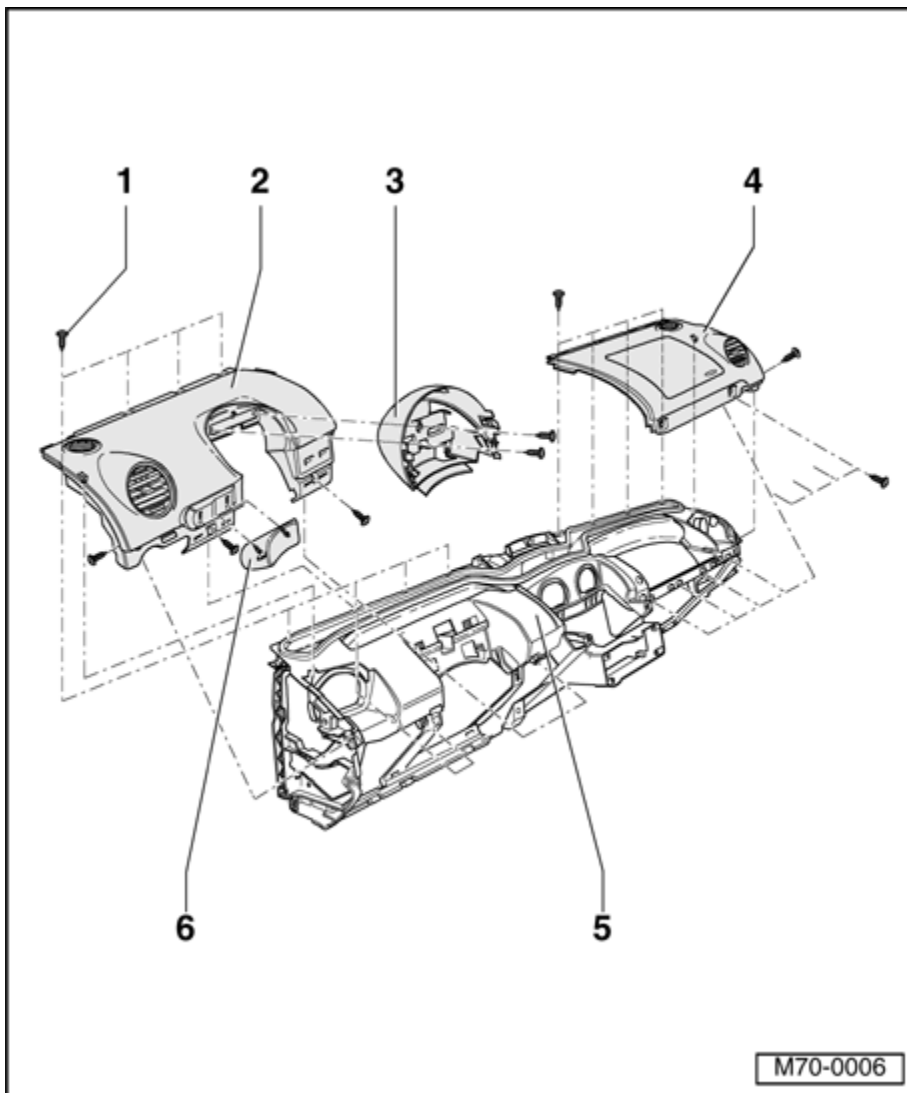
- Remove screws (2x) and remove Instrument cluster housing -3-.

- Remove trim -6-
- Remove screws on under side (Qty. 2), upper edge (Qty. 4) and left-hand side (Qty. 1) of left-hand upper instrument panel -2-. Take upper section of instrument panel -2- off base unit -5-.
- Remove screws on under side (Qty. 4), upper edge (Qty. 4) and right-hand side (Qty. 1) of right-hand upper instrument panel -4-. Take upper section of instrument panel -4- off base unit -5-.

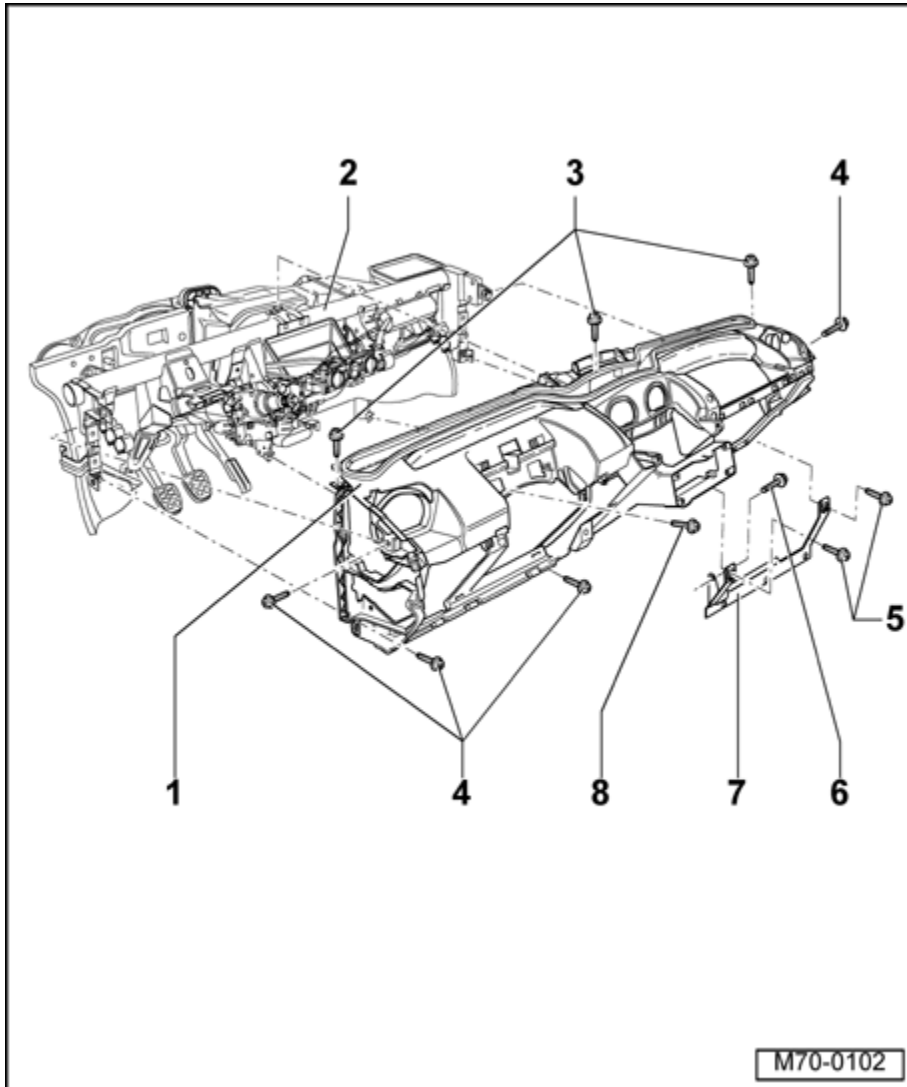
- Remove screws -5-, M8 bolt -6- and remove frame -7-.
- Remove screws -3-, -4- and -8-.
- Remove screws securing fuse panel to instrument panel.
- Remove instrument panel base unit -1- from cross member -2- and remove of vehicle.
